THE HISTORY OF DREDGING IN CLEVELAND BAY, QUEENSLAND AND ITS EFFECT ON SEDIMENT MOVEMENT AND ON THE GROWTH OF MANGROVES, CORALS AND SEAGRASS.

Ada W Pringle (nee Phillips)

Great Barrier Reef Marine Park Authority

© Commonwealth of Australia
ISBN 0 642 12034 X
Produced by GBRMPA
September 1989

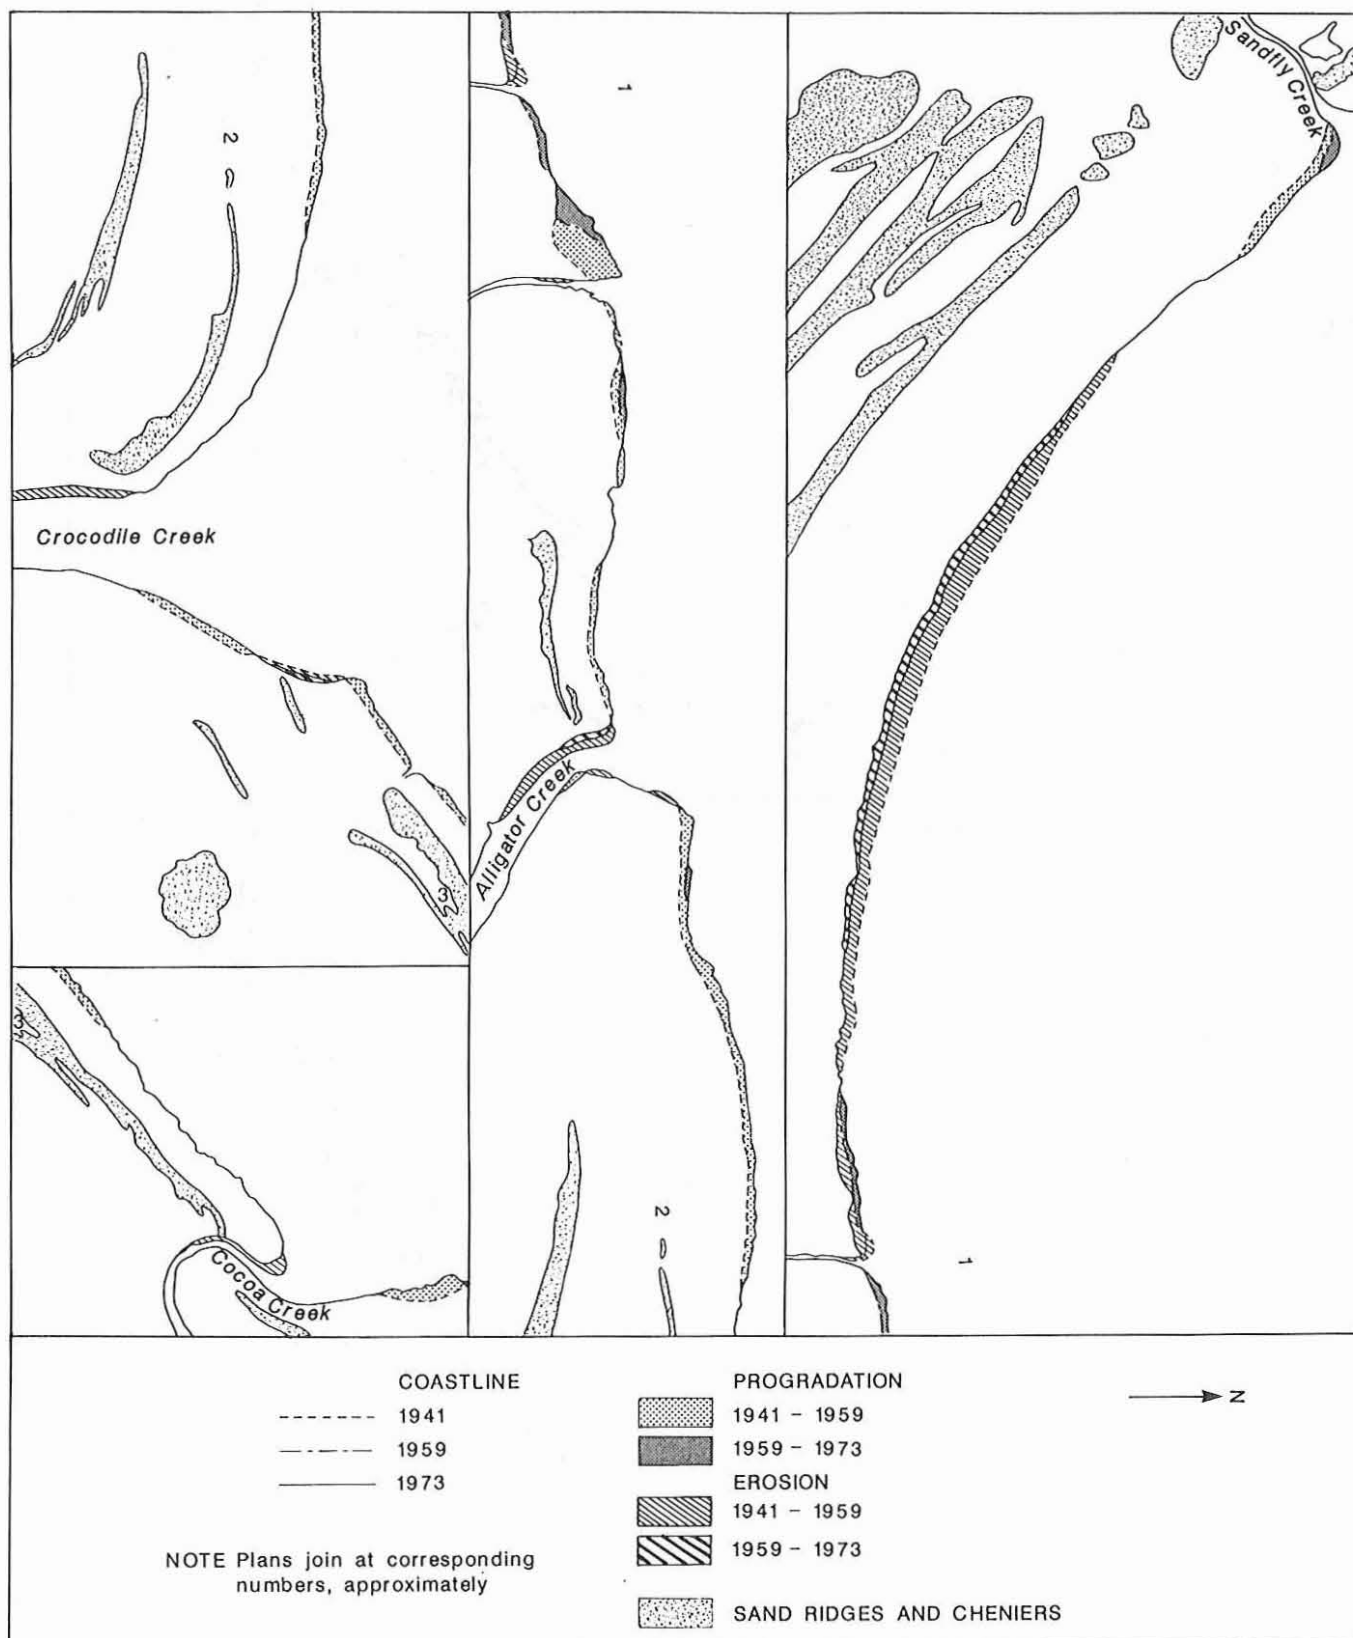
FIGURE 11 Shoreline changes in south Cleveland Bay, between Sandfly Creek and Cocoa Creek 1941-1973. After McIntyre and Associates, 1974.

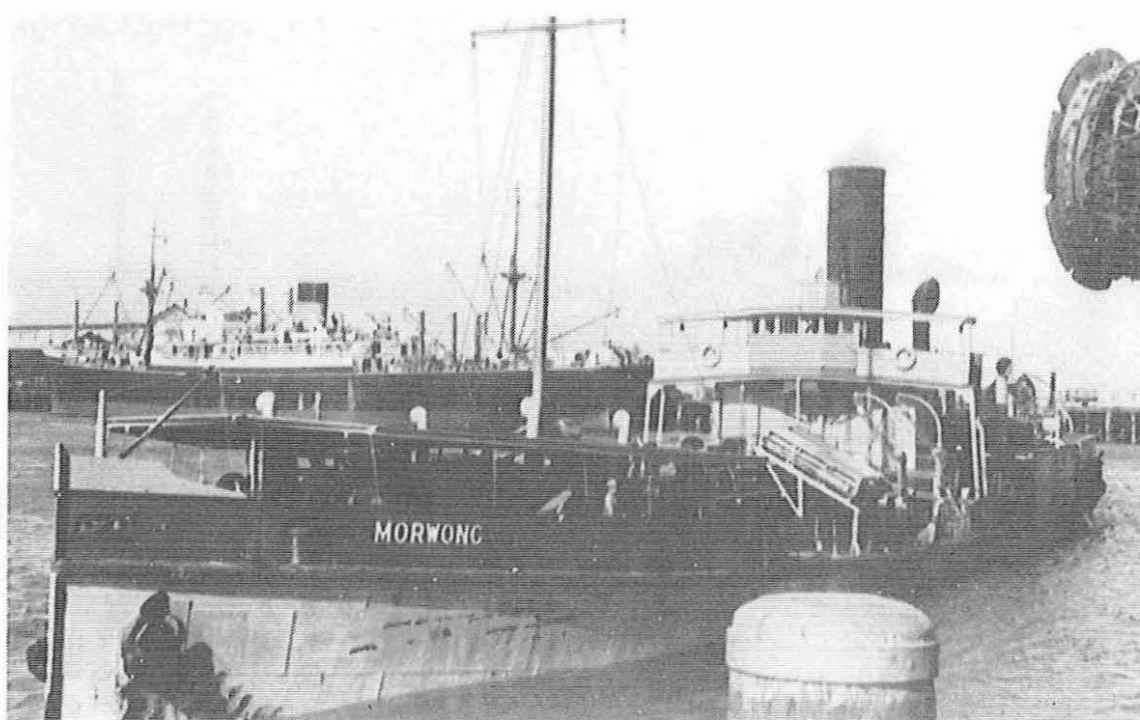
2 Suction Dredge 'Morwong' in October 1946.

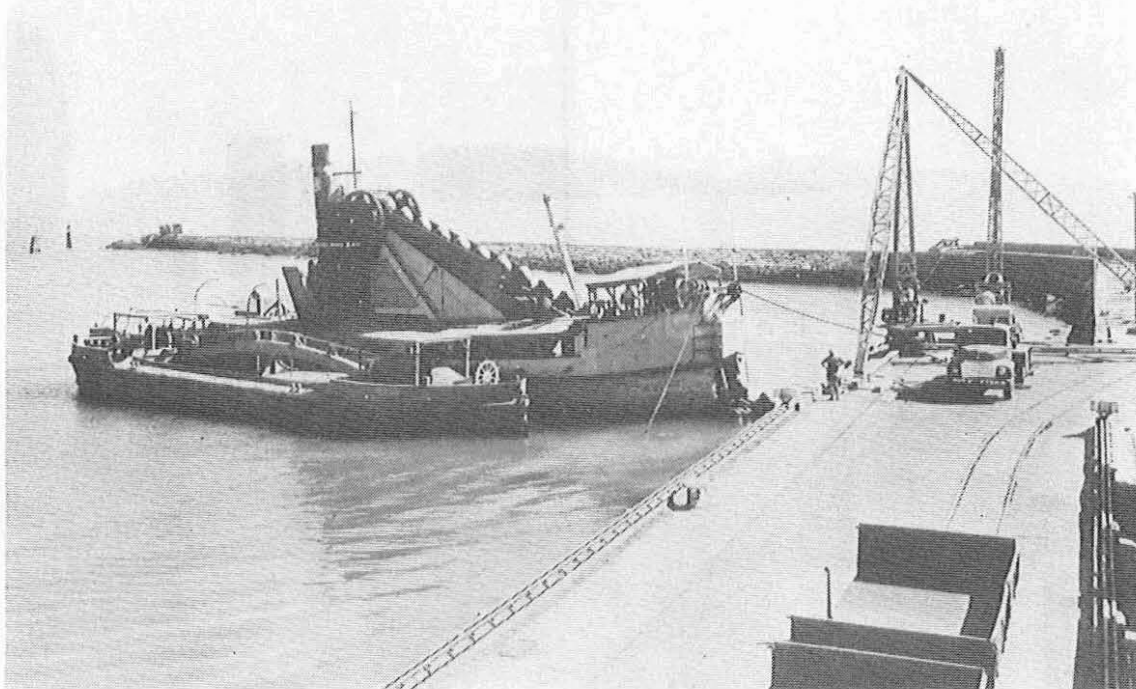
4 Bucket Dredge 'Cleveland Bay' in 1964 on her final assignment, dredging the new oil and tanker berth.
